## Safety Information Bulletin

**SIB No.:** [task 2019.123]

**Subject:** Sailplane Rigging – Procedures, Inspection and Training

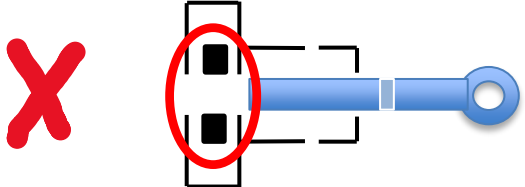
Engaged but <u>not</u> secured.	The bolt moved away from its engaged position, and the control is unconnected.

To engage means e.g. that a bolt is inserted into a bushing. In this condition, the connection is able to transmit forces, but the bolt can move out of the bushing again, therefore the connection is not secure. All connections need to be engaged and secured.

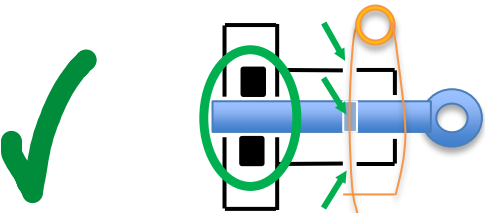
The Fokker-needle needs to be pushed through both holes of the cage and the hole of the bolt.
Engaged and secured.

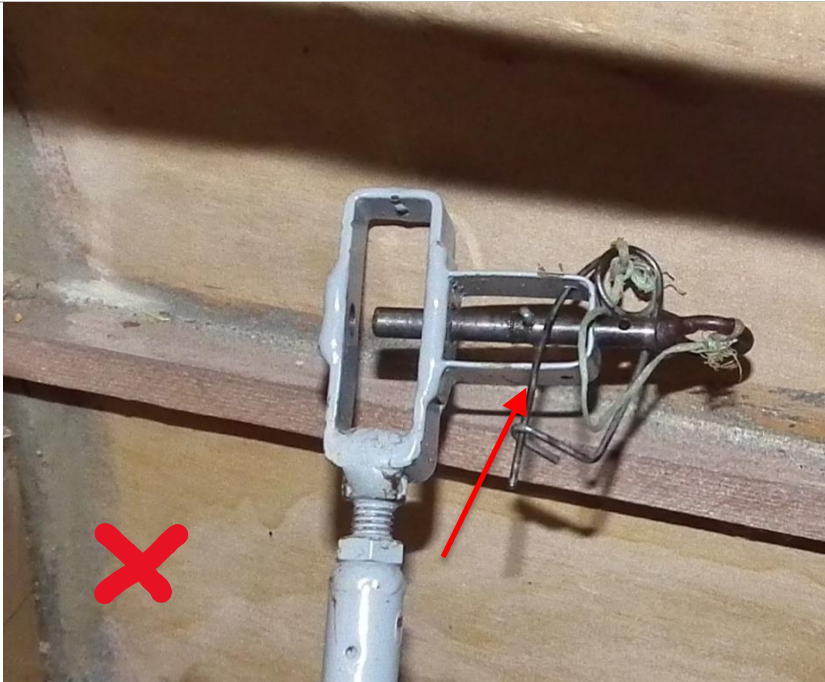
The example below shows an aileron connection, which is typical for old sailplanes with manual control connections. In this case, the connection was engaged during rigging, but not correctly secured. After three flights of short duration, the bolt moved away from its engaged position. The pilot lost control and crashed fatal.

The connection was not secured. The Fokker-needle was put through one hole of the cage only, but not through the bolt and the lower hole of the cage, as well. By this, the bolt could move freely and the control connection could become unconnected.

The bolt is secured by pushing the Fokker-needle through all three holes.

*Note: Connections, which are not properly secured, cannot be detected by positive control checks. The proper securing can be verified by visual inspections only.*

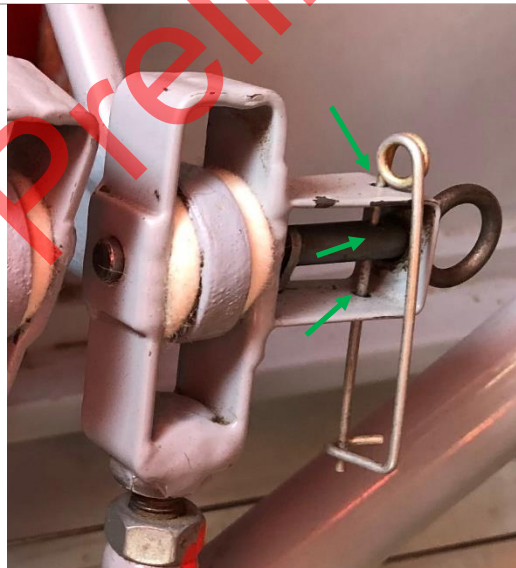
A straight and not bended needle supports its proper application.

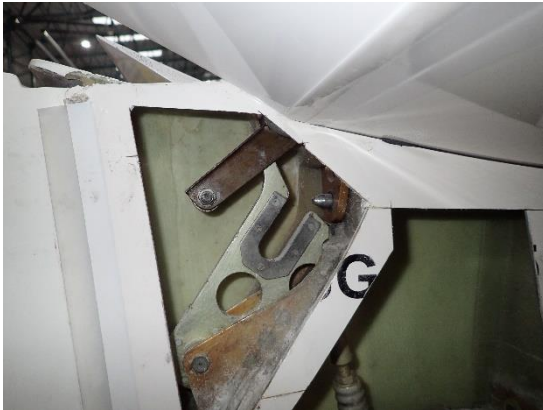
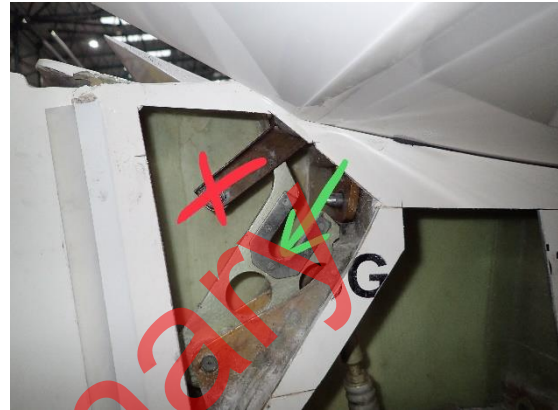
Similar designs can be found for the control connection of the elevator. Pictured below is an example of a miss-rigged vertical stabilizer, which led to a fatal accident.

Disconnected elevator control

*Note: Those examples of rigging errors can usually be detected by a proper positive control check as indicated above.*

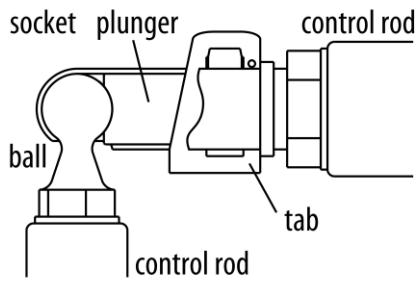
(a) Correct: cut-away shows how tab holds plunger in place

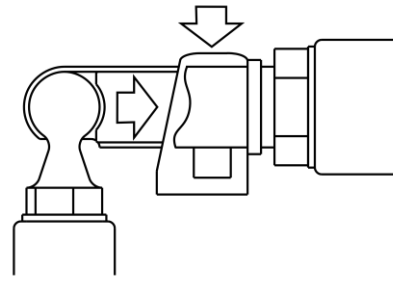
(b) Open: with tab depressed, plunger allows ball to be inserted or removed

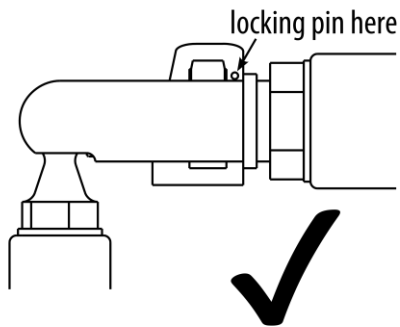
(c) Correct: ball engaged, locking pin may be inserted

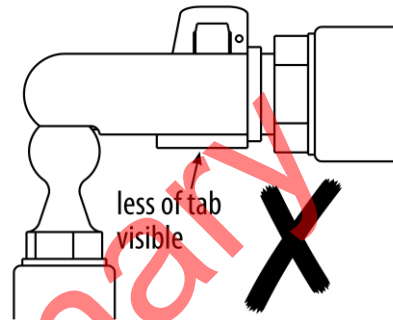
Unfortunately, the tab adopts a similar position when the ball and socket are completely disconnected and, although the ball is then locked out of the socket, it may in some cases engage sufficiently for the controls to seem connected. Being able to insert the locking pin does not guarantee that the connection has been properly made.

(d) Incorrect: ball not engaged, but locking pin may still be inserted

It is crucial to check that the ball and socket are correctly engaged. This can be difficult, if access is tight or illumination poor; a torch and mirror, or telephone camera, can help.

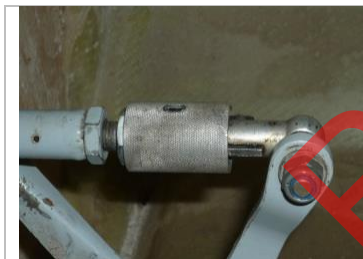
The Wedekind locking sleeve slides outside the l'Hotellier fitting to secure the tab, but doesn't necessarily prevent partial engagement.

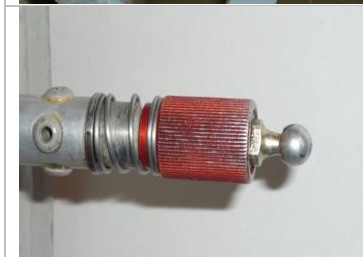
The Uerlings sleeve and similar threaded sleeve used on LS-sailplanes rotate or unscrew over the coupling and cannot be moved into position, if the ball and socket are only partially engaged.

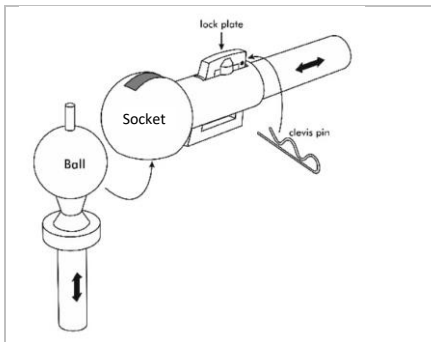
Newer l' Hotellier connectors come with a pin on the top of the ball that becomes visible outside the socket, once the ball and socket are properly engaged. The pin allows also for a tactile inspection. The connection still needs to be secured.

*Note: To check the proper engagement of l'Hottelier connectors, a positive control check is strongly recommended.*

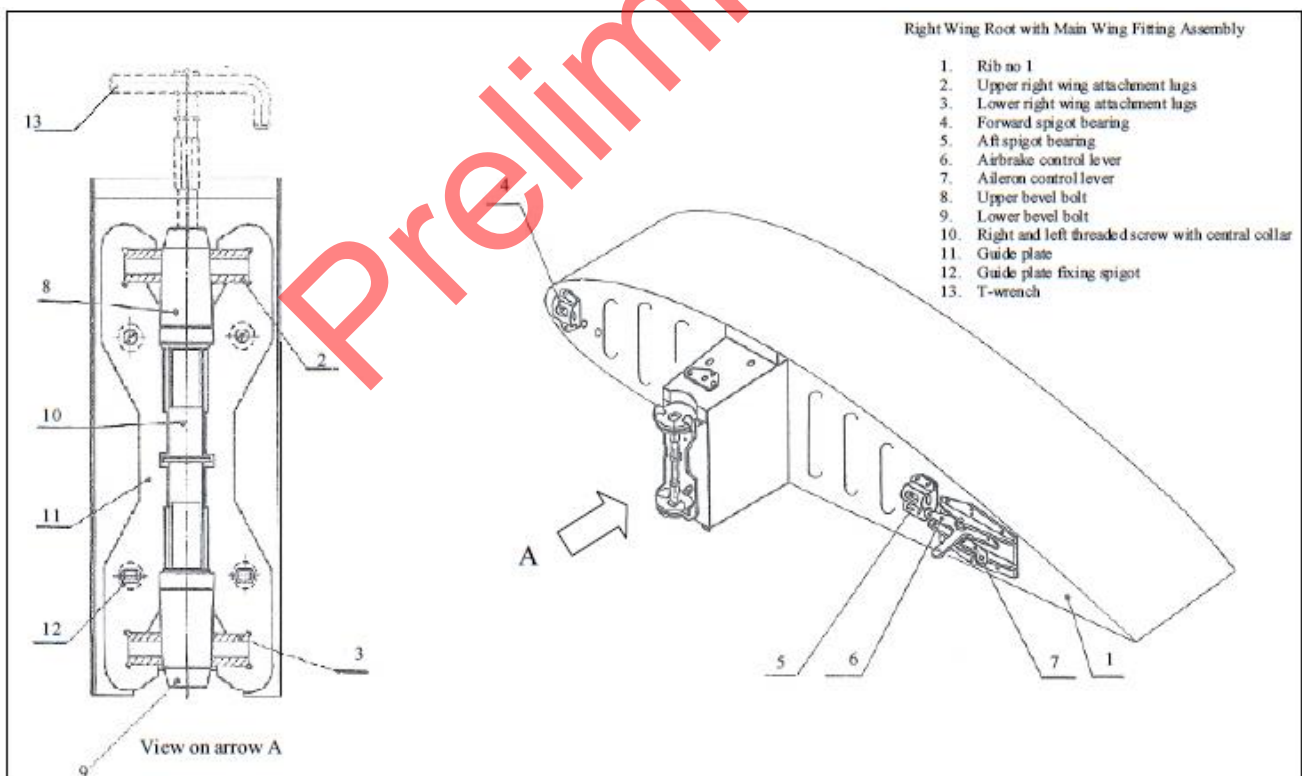
The wing rigging pins for most gliders are smooth cylinders, but those for e.g. the Foka, Cobra, Bocian, Jaskółka, Schempp-Hirth SHK and Austria, consist of expanding pins/cones, which must be fitted exactly in accordance with the instructions of the flight manual. If the pin/cone is not correctly located, the wings can fold up and detach from the fuselage. Unless inspection holes have been cut for the purpose, it can be very difficult in some gliders to see whether the fitting has been assembled correctly.

Example of an expanding main pin wing connection.

*Note: In case of sailplanes with expanding main pin wing connections, practice rigging should be carried out under the supervision of someone who is familiar with the sailplane type.*
